ARMY ENGINEER WATERWAYS EXPERIMENT STATION VICKSBURG--ETC F/O B/S
EROSION CONTROL OF SCOUR DURING CONSTRUCTION. REPORT 1. PRESENT--ETC(U)
MAR 80 L Z HALE
WES/TR/HL-80-3

4. TITLE (and Subtitle)		5. TYPE OF REPORT & PERIOD COVERED
EROSION CONTROL OF SCOUR DURING CONSTRUCTION Report 1 of PRESENT DESIGN AND CONSTRUCTION PRACTICE		Report 1 of a series

6. AUTHOR		6. PERFORMING ORG. REPORT NUMBER
Lyndell Z. Hales		
7. PERFORMING ORGANIZATION NAME AND ADDRESS		8. CONTRACT OR GRANT NUMBER(s)
U. S. Army Engineer Waterways Experiment Station Hydraulics Laboratory P. O. Box 631, Vicksburg, Miss. 39180		(12) 1602

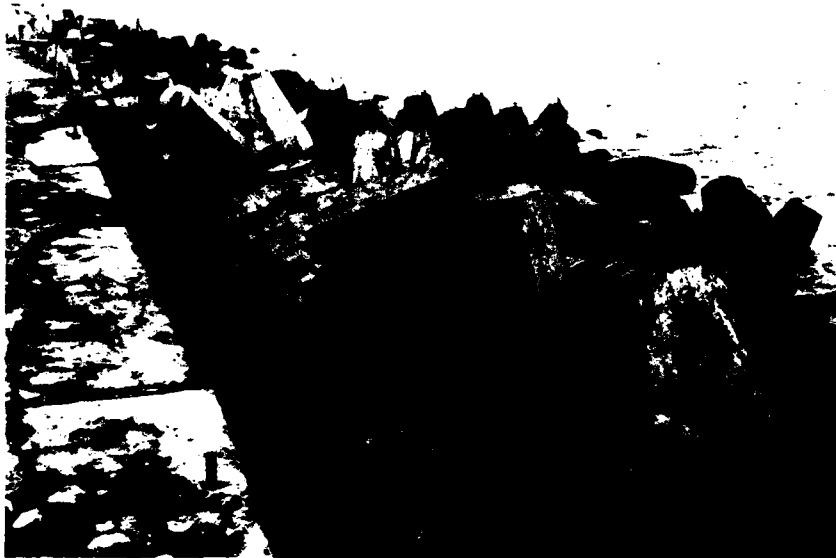
Figure 36. Humboldt Bay Harbor north jetty showing settled condition of 42-ton dolos armor units. 1978
photograph by WES

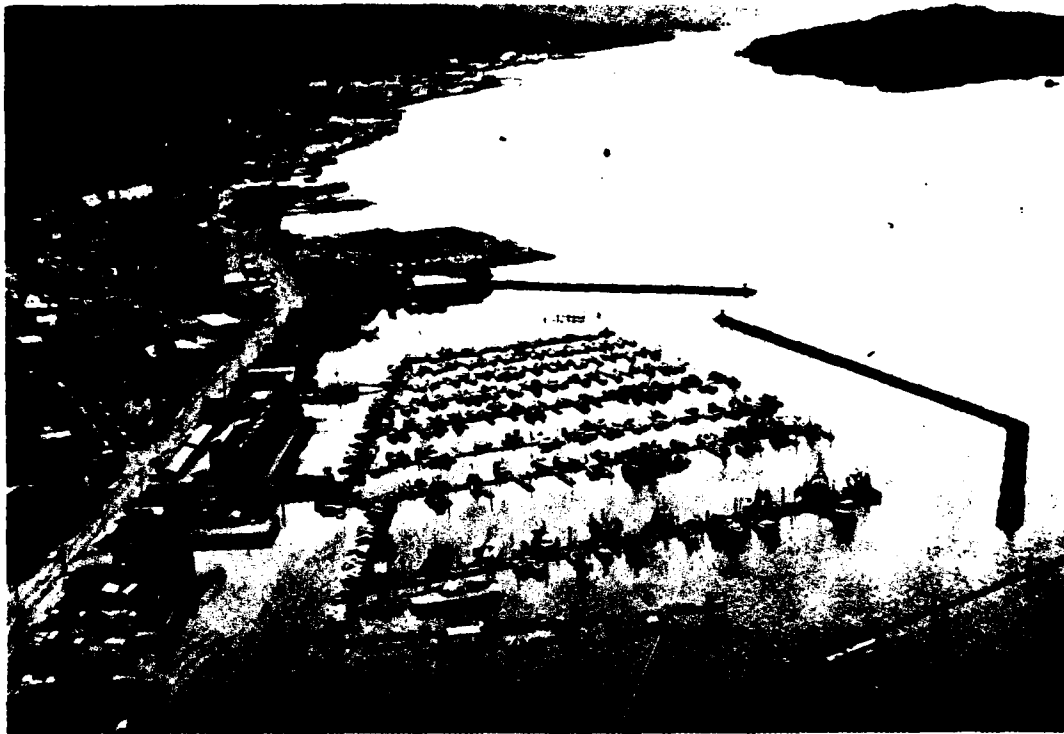
Figure 44. Present status of Bar Point Basin, Ketchikan Harbor, Alaska.
(1975 photograph by U. S. Army Engineer District, Alaska)
